<i>Client</i>	<i>Realtor</i>	<i>Inspector</i>
		<i>David DuBosque</i>
		<i>Integrity Inspections</i>
		<i>South West Florida</i>
		<i>941.650.4267</i>
		<i><a href="mailto:dwd2116@gmail.com">dwd2116@gmail.com</a></i>

## Summary Page

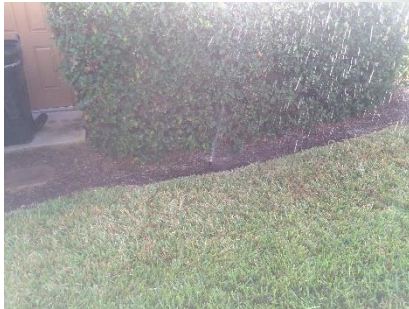
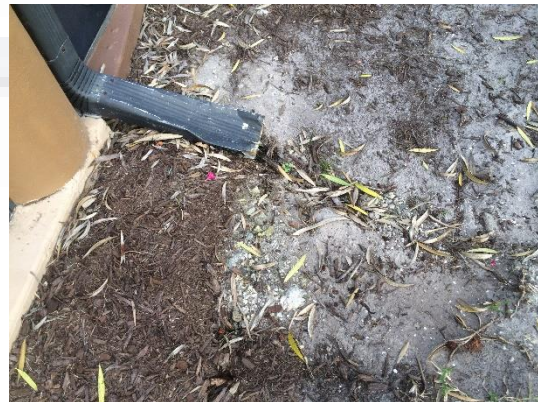
Several of the sprinkler heads will need adjusted and cleaned. Some of the sprinklers are hitting the wall. See wall sections for moisture content on the interior walls.

There is a small amount of soil erosion near the pool deck on the right side and the downspout is crushed.

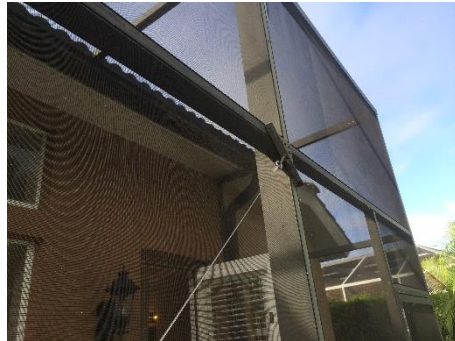
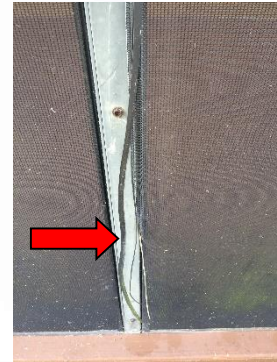
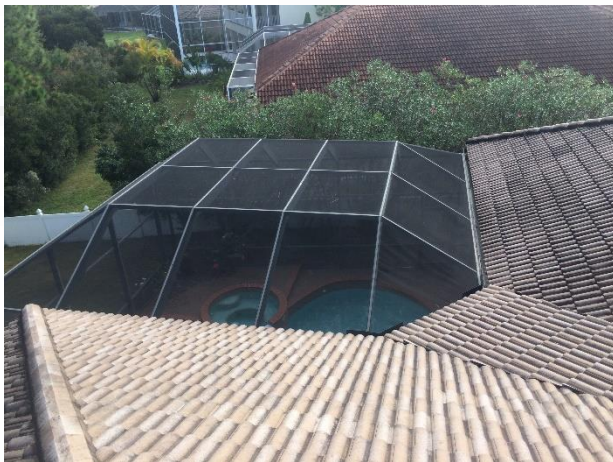
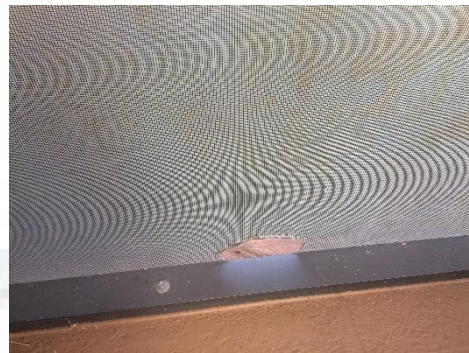
There are a couple holes in the screens and several of the splines are loose (red arrow).

One of the tension wires is loose. This should be tightened.

The pool heater is not working the buried propane tank is leaking. The tank will need serviced before it can be used again.

The pool air switch is not working properly. The equipment does not turn on and off with this broken switch.

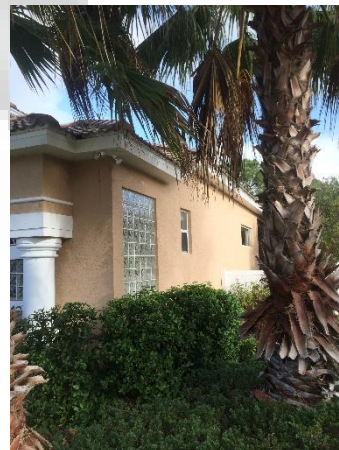
The exterior walls are in good condition.

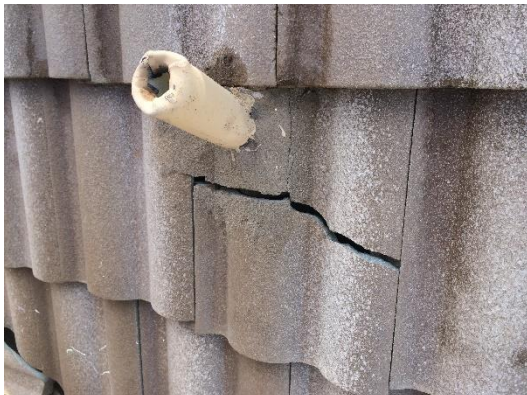
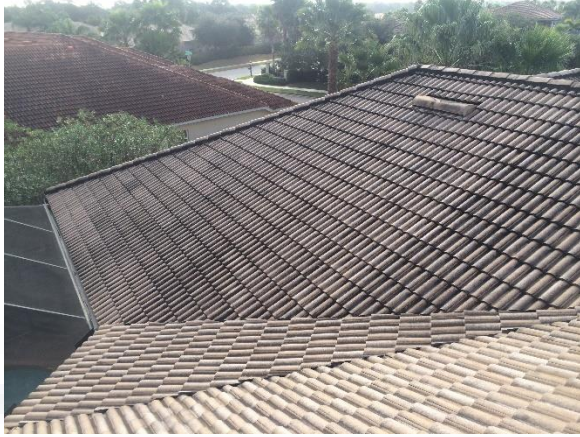
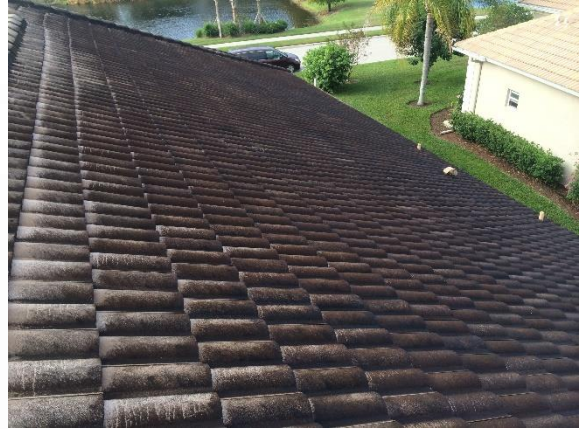
I found one broken tile to the right of the entryway.  
The roof should be cleaned but it is in good condition. I found no evidence of a leak.

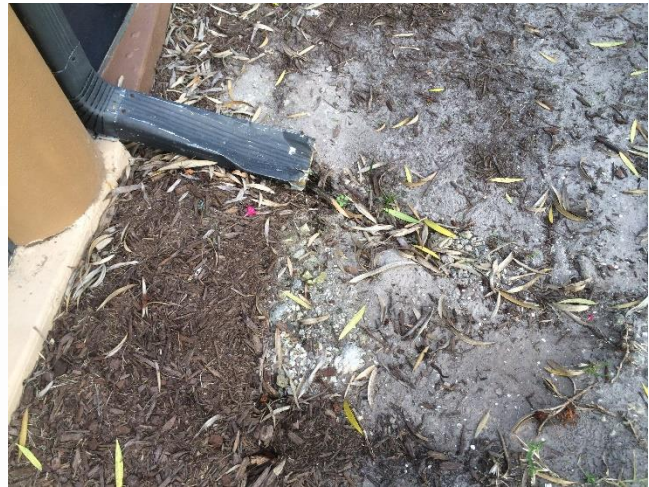
One downspout extension is crushed but the gutters are in good condition otherwise.

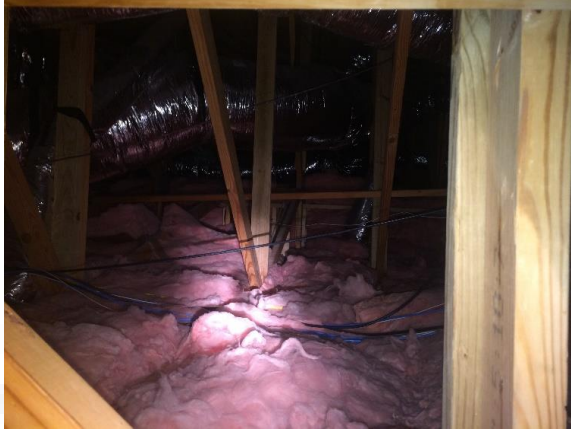
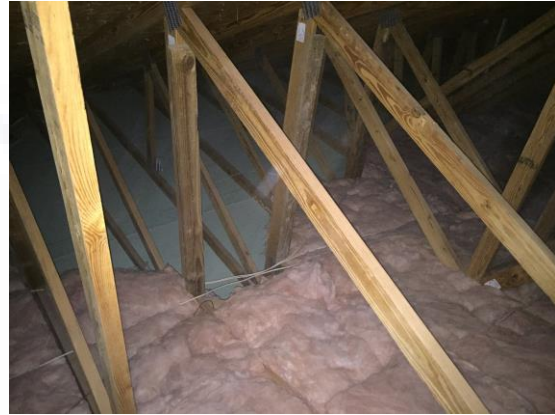
The insulation is R-19 and is in good condition.

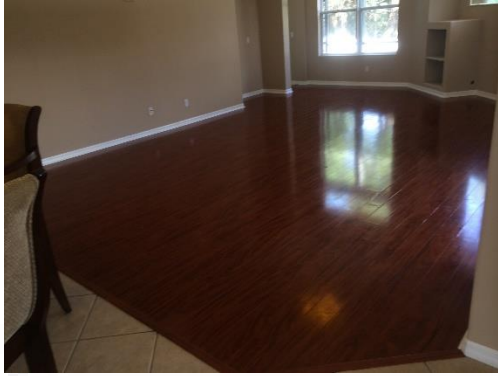
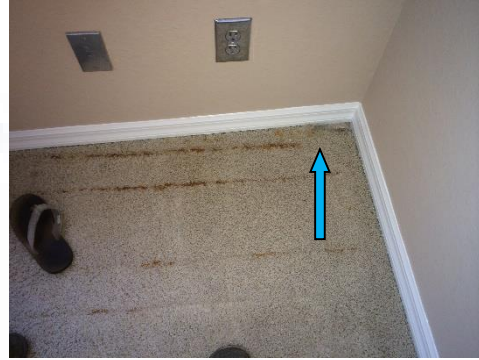
The wood floor is damaged in a few spots.  
The carpet in the front left hand bedroom is stained and damaged from a dog.  
I found several cracks in the tile (Foyer, laundry).

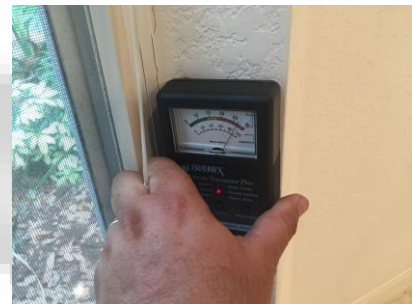
1. Moisture content is high in the middle bedroom. The sprinkler is the cause of this problem.
- 2.
- 3.
- 4.

There is high moisture content in the middle bedroom wall. This is probably due to the sprinkler hitting the wall. They need to be adjusted.

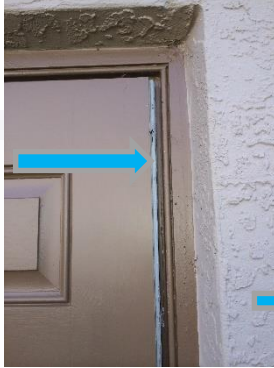
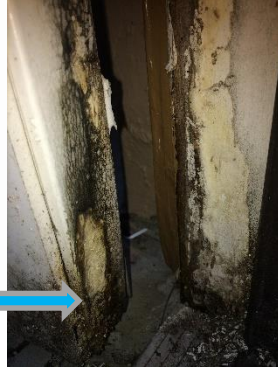
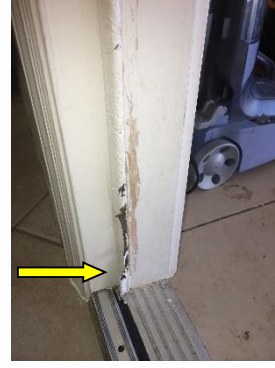
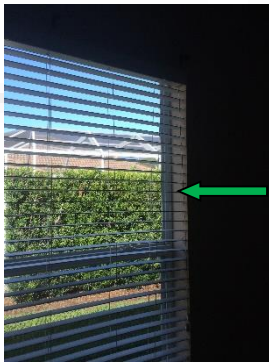
The garage side door (blue arrows) rubs and jamb and has several rot problems.

The weather stripping for the interior garage door is ripped and is allows air to pass by. It should be replaced.

I found one damaged blind.

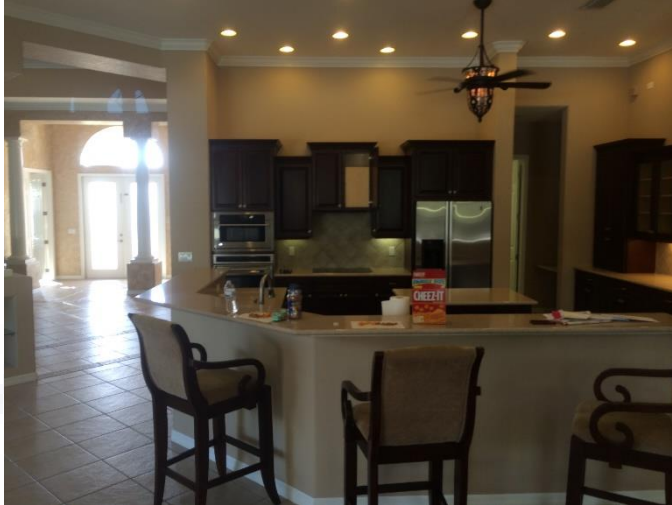
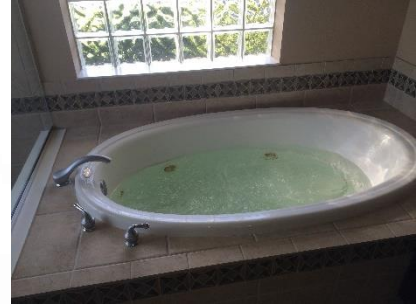
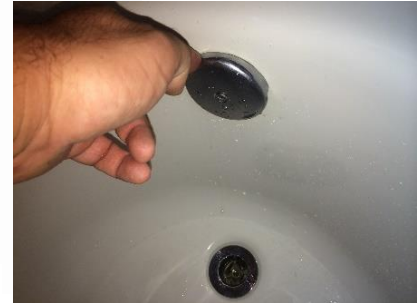
The kitchen is in good condition.

The cooktop front burners do not stay on like the rear burners do. These burners should be repaired or the cooktop replaced.

The whirlpool tub is working well.

The Jack and Jill bathtub overflow is loose. This should be tightened.

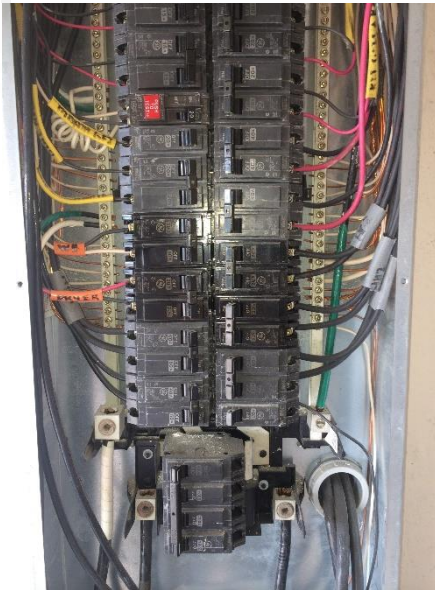
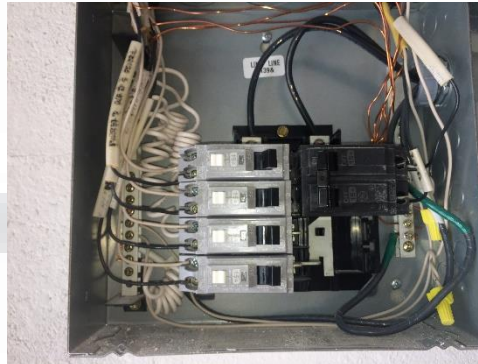
There are several bulbs that need replaced in the house. (Pool, shower area, exterior by condensers)

The electric panels appear to be in good condition.

The exposed electric for the pool light is a safety hazard. This should be covered up.

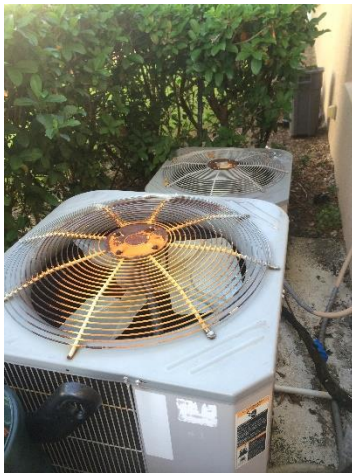
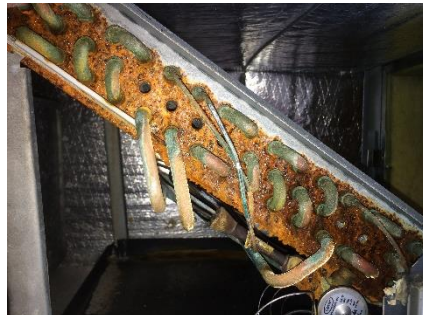
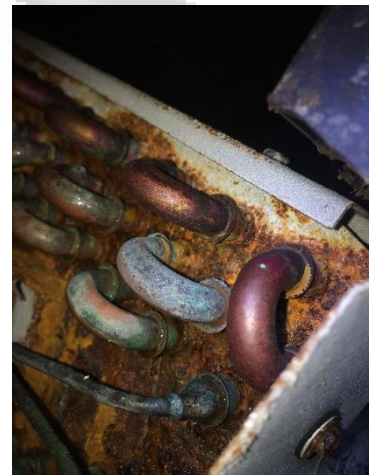
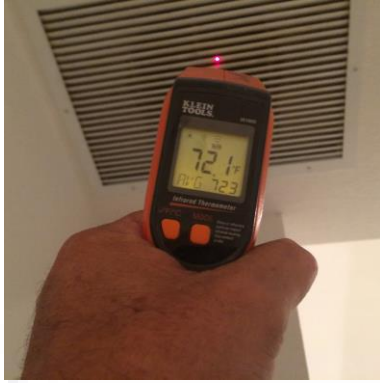
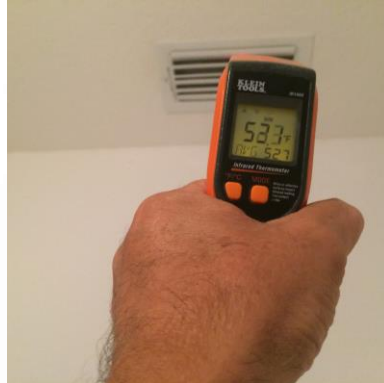
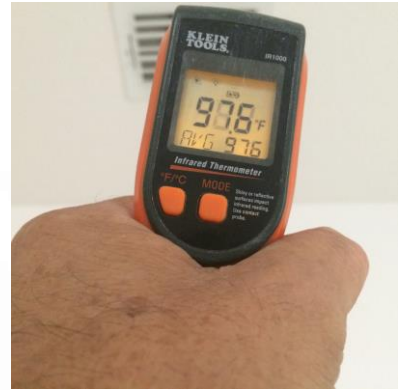
The HVAC systems are original to the home. I found mold on the exterior of the units which is common when the unit is in the garage. This should be cleaned. The interior of the air handler is corroded which is also common with the age of the units. Both units are working well and have a 15 degree temperature change from supply to return. The filters are dirty and should be changed.

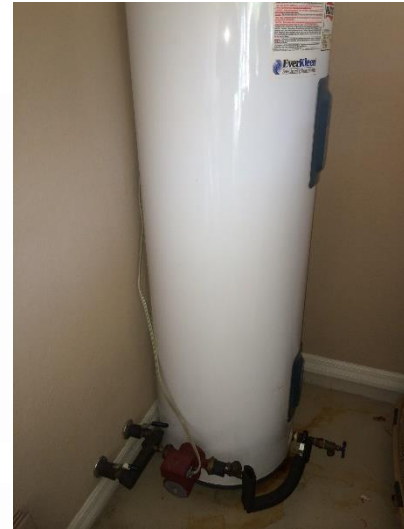
The water heater is working but does have a small leak. The water heater will need to be replaced to fix this problem.  
The circulating pump is working well.

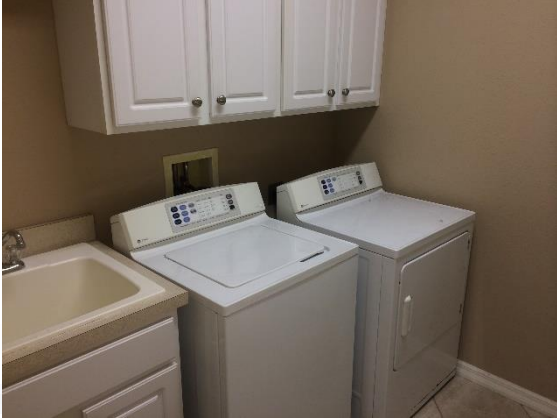
The washer and dryer are working. The dryer is not connected to the vent and is blowing moist warm air into the room. The bottom of the dryer is rusted.

The caulking around the laundry tub will need redone.
